General Electric Advanced Technology Manual

Chapter 4.10

Shutdown Plant Problems

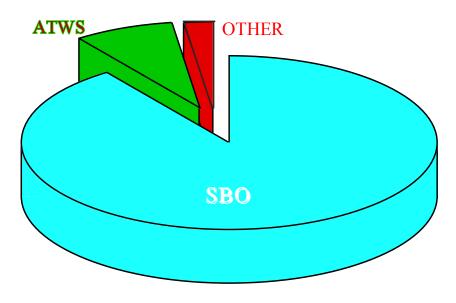
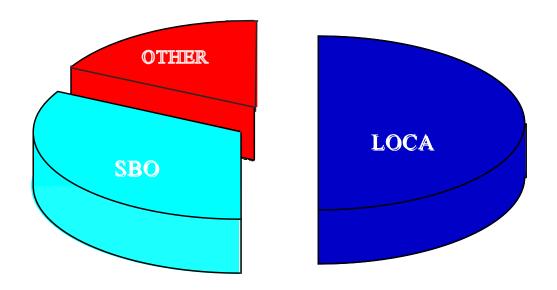
Figure 4.10-1 Accident Sequence Comparison

Full Power

Low Power & Shutdown

Figure 4.10-1 presents a comparison of the mean core damage frequency percentages for the major classes of accidents from both the full-power NUREG-1150 and the low power and shutdown mode analyses NUREG/CR-6143. From this figure, obvious similarities and differences can be seen. The major similarity observed is that in both analyses the station blackout (SBO) class is important. In the full power analysis SBOs are dominate accident sequences due to the loss or degradation of multiple systems. In operating mode 3 and 4 SBOs also show up because they still cause loss or degradation of multiple systems. However, there are additional accidents that can cause loss or degradation of multiple systems because of considerations unique to those modes of operation.
